Project BRACER

*Technical Report of the Remediation of the Biological Waste
Pits Located Behind Building H-55, CFB Kingston, Ontario*

Technical Report
DRDC Suffield TR 2003-034
April 2003

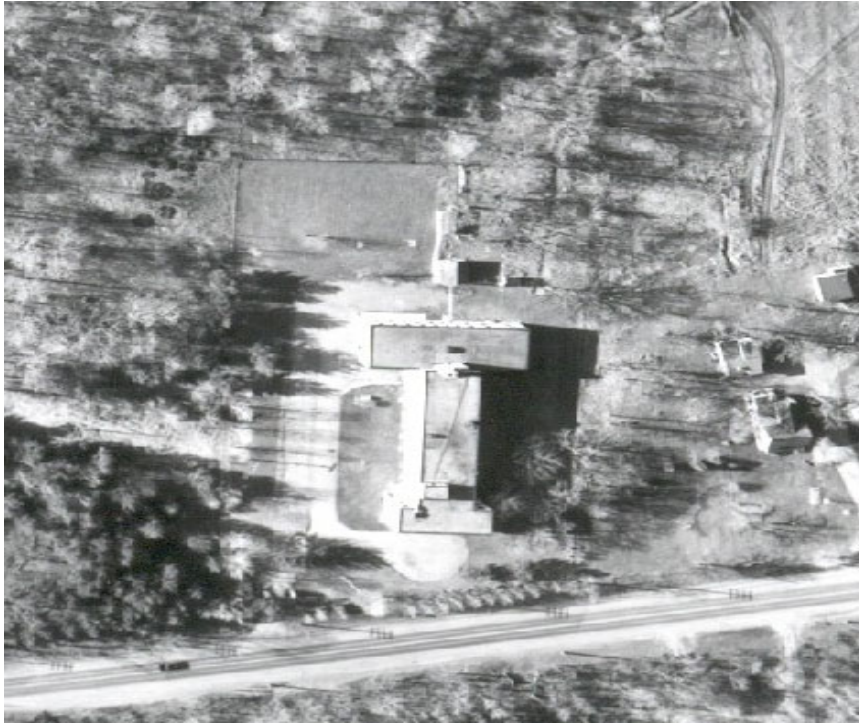
Fig.1. Aerial view of Building H-55 taken in 1965

A site plan for the H-55 area at CFB Kingston was reviewed and integrated with aerial photographs of the site (Fig 1).

The use of aerial photography assisted in the positive identification of a fenced area of approximately 800 square metres. This fenced area was typical in that sites of similar geometry have been found at other research establishments and facilities with known field trial programs, training areas and hazardous waste disposal sites. A detailed geophysical survey of the area that included the inner fenced area and regions outside the fenced site was conducted using electromagnetic survey equipment.

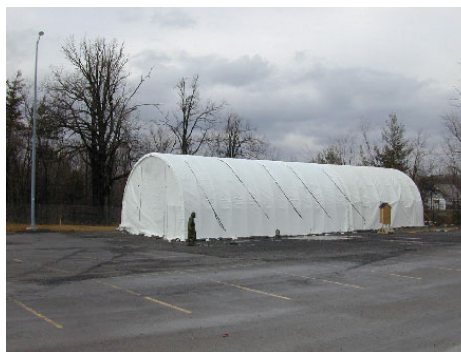
Fig 2. *The disposal pit covered by environmental structure*

The site excavated was the disposal pit located approximately 60 m north east of building H-55 (Fig 2).

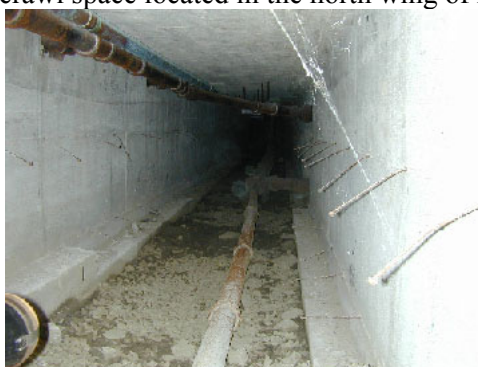
Fig 3. *Crawl space located under Building H-55*

The crawl space located in the north wing of Building H-55 (Fig 3).

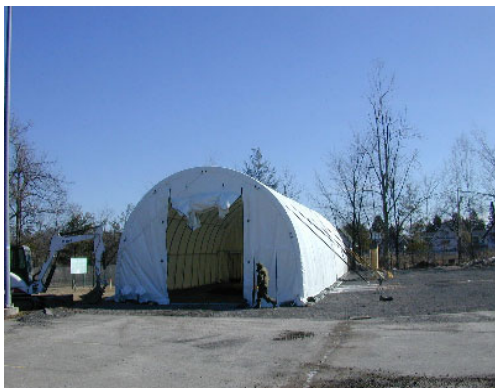
Fig 4. Environmental containment structure situated over the site

A three man advance team from Suffield arrived at the Kingston site February 28, to begin site preparations. The majority of DRDC Suffield, Ottawa and HYTEC equipment had been pre-deployed to CFB Kingston in preparation for this initial phase. The advance party was responsible for the placement and erection of the environmental structures (Fig 4) and installation of other support facilities such as the DRDC decontamination trailer and medical service facilities (Annex A) (Fig 5). Installation and maintenance of electrical services was completed by the CFB Kingston electrical department. Other direct support was provided by the facilities Heating Plant personnel and General Labor crews from the Base.

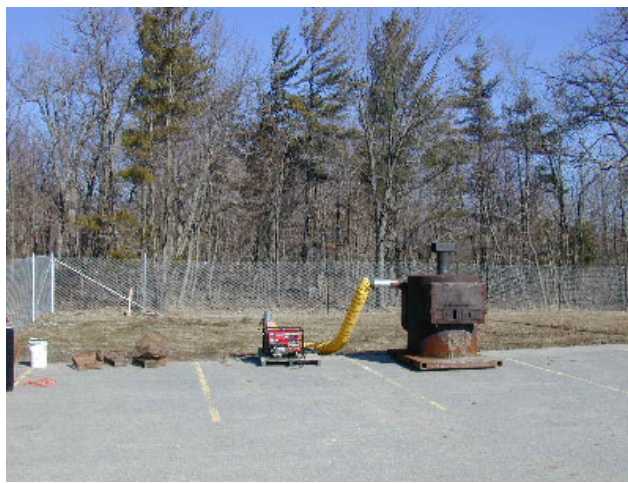
Fig 8. Thermal Neutralization Unit (TNU) with power generator and air blower system.

The Thermal Neutralization Unit (TNU) developed at DRDC Suffield is a free-standing, cylindrical steel tank employed in the thermal treatment of neutralized Chemical Warfare Agents (CWA), primarily mustard, and other combustible and non-combustible laboratory waste. Methanol (methyl alcohol) (Annex C) is used as a combustion fuel for the TNU which is equipped with a small exhaust stack, forced-air inlet, and double steel doors that are secured during the combustion process. The fuel volume of the TNU is approximately 750 L or 3 x 45 gal drums of methanol (Fig 8).

During the combustion process, stack monitoring is carried out using Chemical Agent Monitors (CAMs) to confirm that the stack gases (primarily carbon dioxide and water vapour) do not contain agent. The combustion process and temperature can be controlled at all times through the speed setting of the forced-air fan. Methanol combustion is inherently clean with little or no observable smoke (particulate matter).

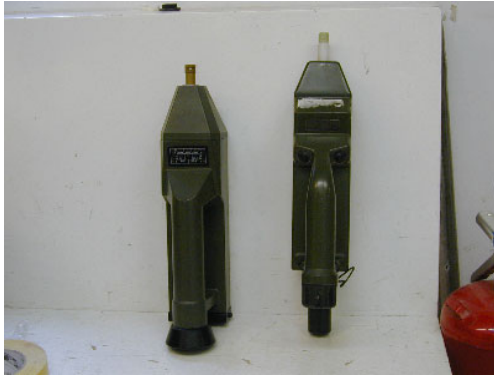
Fig 9. AP2C (left) and CAM Chemical Agent Monitors. Both systems were employed during the project providing field operators with real time monitoring capability.

A full suite of chemical detection and monitoring systems were employed during the conduct of all intrusive operations and product analysis operations. This included hand held Chemical Agent Monitors (CAMs) supplemented by the AP2C (Fig 9) as well as Nerve Agent Vapour Detection (NAVD) tickets and Detector Paper (Fig 10).

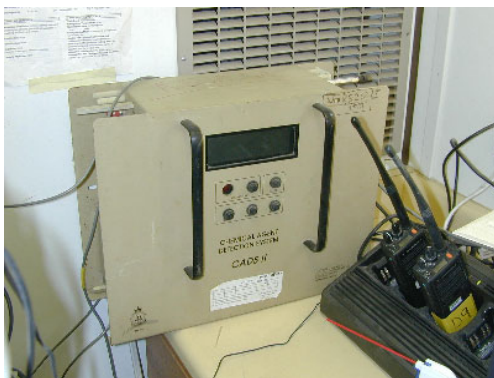
Fig 11. Chemical Agent Detection System (CADS) Central Processing Unit (CPU) located in the decontamination trailer control room.

Hand held CAMs and the AP2C detection systems were supplemented by remote Chemical Agent Detection Systems (CADS) (Fig 11), strategically positioned prior to the start of daily operations. Two systems were active at all times during intrusive investigation and soils-blending operations, with one station positioned inside the environmental structure and the second station being outside, in a downwind location to monitor for any possible airborne contaminants. Each CAD system employed two CAM's, one "G" mode (nerve agent), the other in "H" mode (mustard). Monitoring data from each station was sent remotely to the Central Processing Unit (CPU) (Fig 11) that was installed in the Decontamination Trailer. Had agent been detected by either the internal or external CAD station an audible alarm would have been activated.

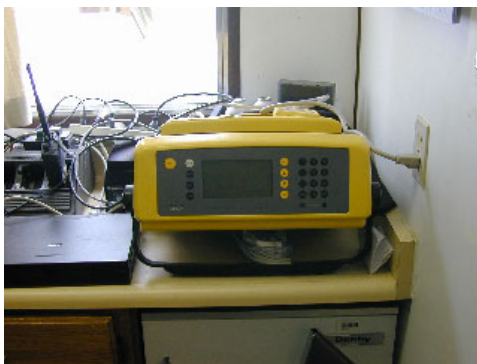
Fig 13. Hapsite GC\MS

The DRDC Team had a portable Hapsite Gas Chromatograph\Mass Spectroscopy (GC\MS) (Fig 13) vapour detection capability. Although infrequently used during Project BRACER, this analytical tool is equipped with a comprehensive CWA library. The system is further complimented by an independent head space heater\analyser which provides the capability to retrieve otherwise unobtainable data from cold soils and contaminated materials.

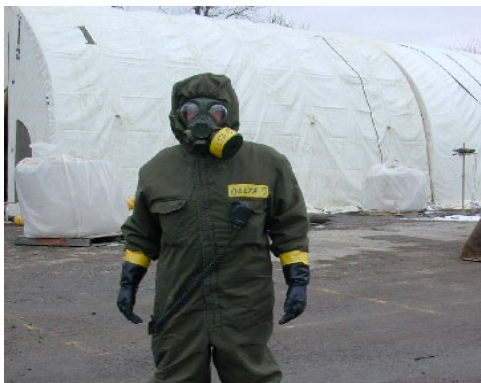
Fig 14. DRDC Team member in full Level II protective ensemble

All workers on site were required to wear the same level of individual protective equipment; (Fig 14) that is, if activities were underway that required FULL protection, no worker would wear a light protective ensemble on-site (Fig 15). The project team issued FULL protective ensemble to contractor personnel in cases where such personnel could have been exposed to CBR materials during intrusive site work, e.g. excavations. In instances where contact with liquid waste was possible, plastic splashguard material could have been worn on the sleeves and torso of the FULL protective equipment to increase protection against liquid splashes. For operations under cold ambient conditions, each level of protection was augmented by thermal underwear and innerwear, e.g. Wind River sweaters and pants, with the proviso that such innerwear was subjected to the normal clothing decontamination procedures during site operations.

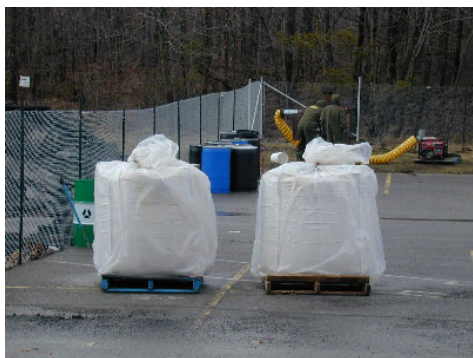
Fig 16. Zeolite as delivered in one ton totes.

HYTEC Hydrocarbon Reclamation Ltd of Calgary, Alberta were contracted by DRDC Suffield to effectively blend and treat recovered soils as part of the remediation process. Blending operations included excavation of soil from site and blending it with Crystalline Aluminosilicate (PCA.Z-2) Zeolite (patented). (Figs 16 and 17)

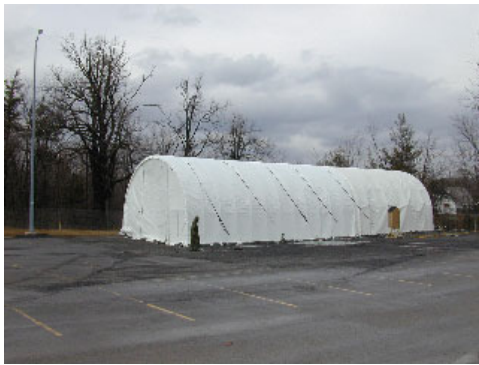
Fig 18. Two containment structures in place over the site; the structure to the east (right) is the 32 foot unit, the structure at left (black tie-downs) is the larger 48 foot unit.

The site excavation was covered by three portable self-supporting Environmental Structures connected by specially designed joint flaps. (Fig 18) The three structures were similar in that they were 26 feet wide and 17 feet high, however the centre section was 48 feet in length as opposed to the two end units that were 32 feet long. Each individual unit was fitted with internal door closures allowing for separation between individual units. The structures were sited in an east to west orientation, with the eastern most structure and centre unit covering the actual dig area while the third (west) structure housed the soils blending unit and ancillary equipment. The project plan demanded an area over 50 feet wide x 80 feet in length be excavated to bedrock meaning all three structures had to be relocated one width (26 feet) directly to the south to accommodate project demands.

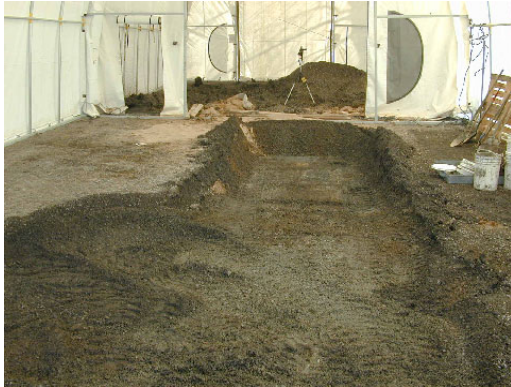
Fig. 20. The gravel seam being cleared from atop the site

A gravel seam (12 inches thick) was identified as the sub-base for the parking lot covering the entire site (Fig 20). The gravel layer was identified during interpretation of the geophysical survey

information. The gravel was removed from atop the indigenous clay (Fig 21) and relocated to a holding area on the north-east corner of the site. Prior to and during gravel removal operations, the material was screened continually for the presence of CBR contaminants using Chemical and Radiological monitoring and detection equipment.

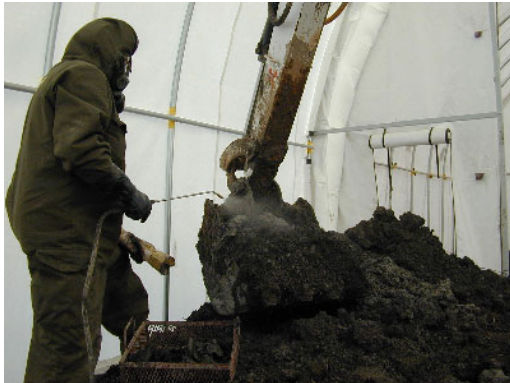
Fig 22. Bleaching of excavated soils “a precautionary measure”

In addition to the extensive use of sensitive detection equipment, the team employed two electrically powered misting systems filled with 10% solutions of chlorinated bleach and water. (Fig. 22). This precautionary measure, part of the Field Technical Operating Procedures, was to ensure that in the unlikely event any biological material from the research programme had been deposited in the dump-site and had in fact survived the many years of burial, it would be effectively eradicated when exposed to the bleach spray and

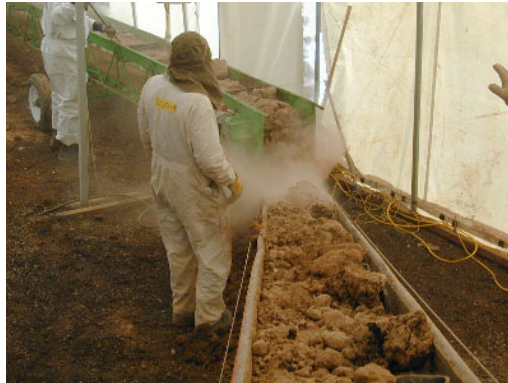
Fig. 23. Bleaching operations involving excavated soils.

misting operation. In addition to this, excavated soil (Fig. 23) being conveyed to the blending process was subjected to secondary misting and spraying operations, further minimizing the chances of airborne biological materials surviving.

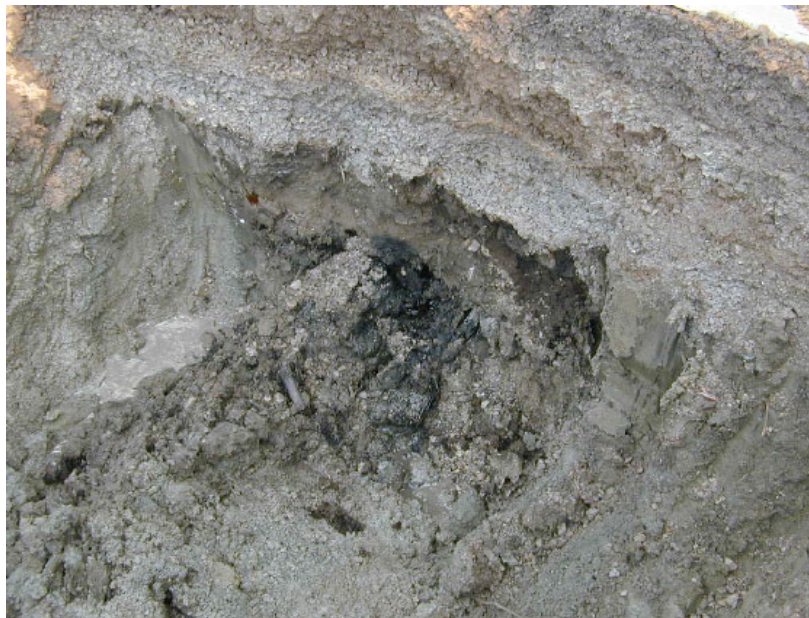
At 11:12 am 02 March, the Field Technical Manager (FTM) reported that the “end” of what appeared to be a disposal pit had been uncovered; the recovery team was working from the east end of the structure moving in a westerly direction when the pit was discovered. (Fig 24). A number of anomalous items (glass tubes and plastic) were uncovered and digging operations were suspended while a detailed investigation of the immediate area was initiated; this included radiological and CAM surveys of the recovered product and surrounding soils.

Detailed updates of the investigative and analytical process were sent directly to the Project Manager; initial recovery operations resulted in the retrieval of laboratory glassware and approximately 25 culture tubes (typical of those from a biological program). The tubes were in some cases intact (sealed), however the majority were in various states of deterioration, including broken and ruptured condition. The sealed tubes were partially filled with a reddish brown liquid. (Fig 25). A number of these sealed items were segregated and taken to the PANS for further analysis and testing; each tube was opened and subjected to a number of tests including detector paper (negative reaction) and pH analysis resulting in a pH level of 12, suggesting the material originally resident in the tube had been exposed to decontamination processes. The test procedures confirmed no CB or R agents were present in any of the material or items tested. Monitoring of the excavated area and of product interlaced in the soil was done on a regular basis to ensure no CBR material was present. As a precautionary measure, and in keeping with operational and

Fig 24. *The exposed end of the disposal pit with test tubes, plastic and laboratory waste material clearly visible in the excavation; testing revealed no CBR contamination.*

Product removal and waste segregation operations continued for the remainder of the day; any unopened containers were crushed under neutralization solutions resulting in the accumulation of quantity four 20 litre pails filled with neutralized product, solid waste (glass) and solution. Each pail of material including the neutralization solution was checked for the presence of CBR; although no levels of CBR agents were ever detected standard procedures and protocols demand that all recovered material be subjected to neutralization procedures which include being immersed in solutions of 10% Potassium Hydroxide (weight\volume) in methanol. After a pre-determined “soak” time the solution is drained for re-use and the cleansed material transferred to the Thermal Neutralization Unit (TNU) for final reduction.

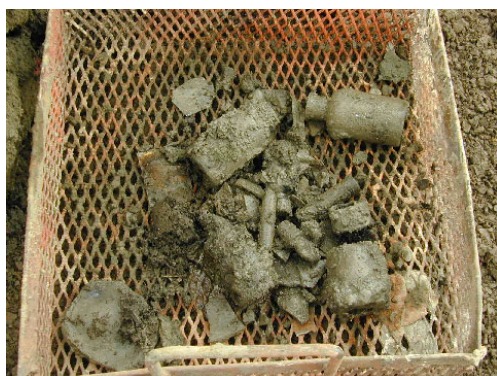
Fig 28. Typical waste recovered from the excavation. Note the different container dimensions.

A total of 24 jars (Fig 28) and bottles of varying geometry were recovered (Fig 29) over the life of the dig, and secured in sealed containers (20 litre pails). Each item was opened and the contents subjected to testing; all were determined to be water-filled and no CWA or radiological contamination was detected. As in keeping with procedures, the items were immersed in mixtures of potassium hydroxide and methanol prior to being placed in the TNU.

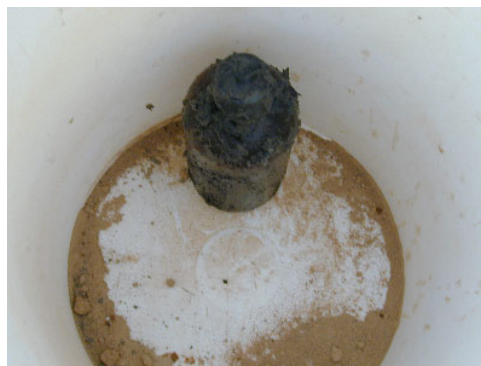
Fig 29. A typical 250 ml bottle recovered from the pit; this item contained 20 ml of water.

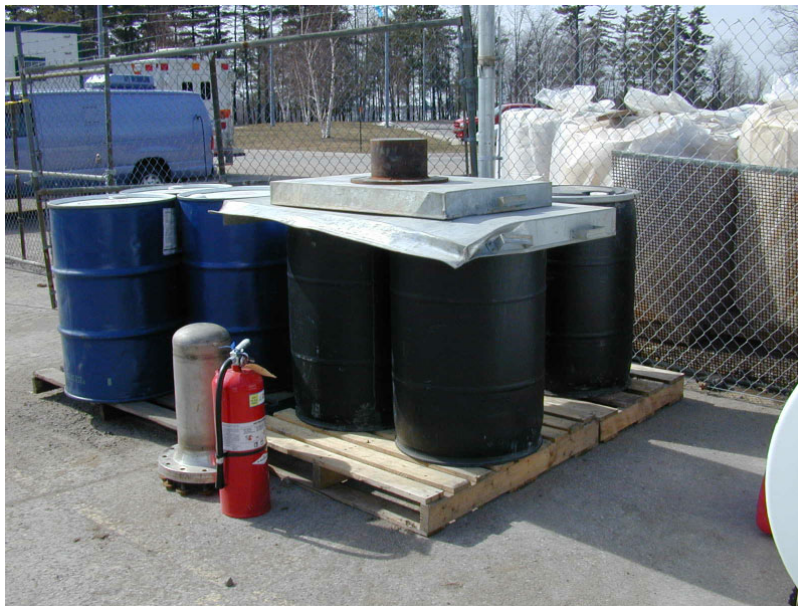
Fig 30. Once surveyed for CB and R contamination, ash from TNU operation is stored in 45 gallon drums.

Post combustion, the TNU contained residues of potassium; CAM and radiological protection equipment was used to survey the interior compartment of the TNU as well as the reduced waste. Surveys were carried out while the interior temperature of the TNU was above 25 °C.

Waste recovered after TNU treatment was carefully packaged in approved 45 gallon waste containers and labelled. CFB Kingston hazardous material management personnel ensured the waste was transported off-site for disposal at commercial facilities.

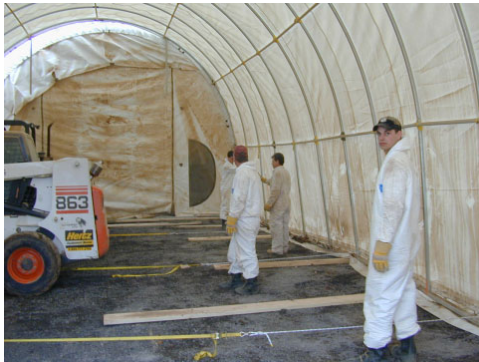
Fig 31. Field Technicians preparing one of the containment structures for its relocation

Before blending operations could begin, all DRDC project team equipment that had been strategically positioned in the containment structure had to be relocated to maximize available space. This proved to be a significant challenge since the operational capability of the equipment had to be maintained in anticipation of any emergency situation that could have arisen at any time during soils blending operations. A considerable amount of time was dedicated to the planning and relocation process since improper placement of the equipment could have resulted in difficulties during emergencies and costly time delays.

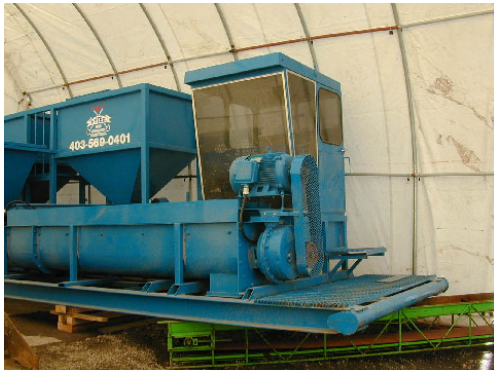
Fig 33. Soils blending unit located inside unit 3 of the containment structure.

HYTEC Hydrocarbon Reclamation Ltd, of Calgary Alberta were contracted to complete the 2000 cubic meter soils blending operations. The co-blending product used was Porous Crystalline Aluminosilicate (PCA) (Z-2 patented). The product has some very unique capabilities with respect to hydrocarbon absorption from soils and other media including CWA and radiological materials. The soils blending operation was a considerable undertaking especially in light of the time constraints and the fact that all three containment structures had to be relocated so as to accommodate the area requiring excavation, blending and replacement. HYTEC provided the specially designed equipment used to efficiently and effectively blend recovered soil with Zeolite.

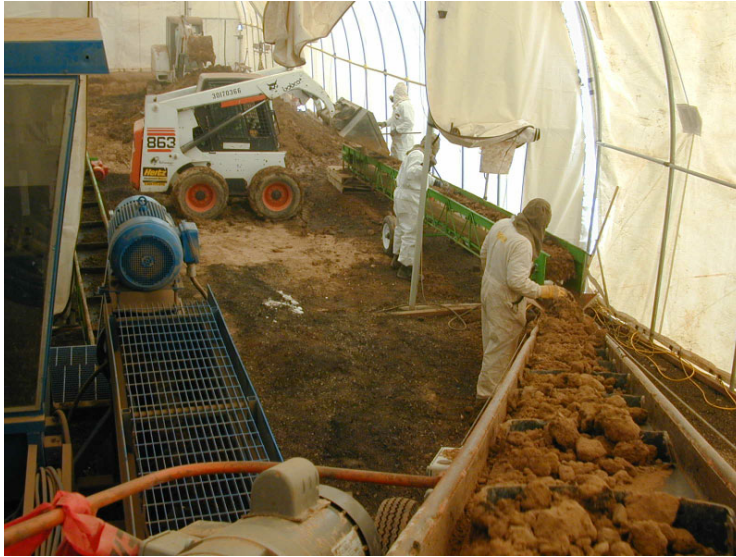
Fig 35. Soils being delivered to the conveyor system. Note the field operators inspecting the soil for anomalous items or material.

To ensure sufficient throughput of soil, a series of conveyor systems and equipment capable of efficiently moving the soil were employed (Fig 35 and 36). Material and soils being transported also had to be visually checked for any product or items that may have gone undetected during the initial screening process.

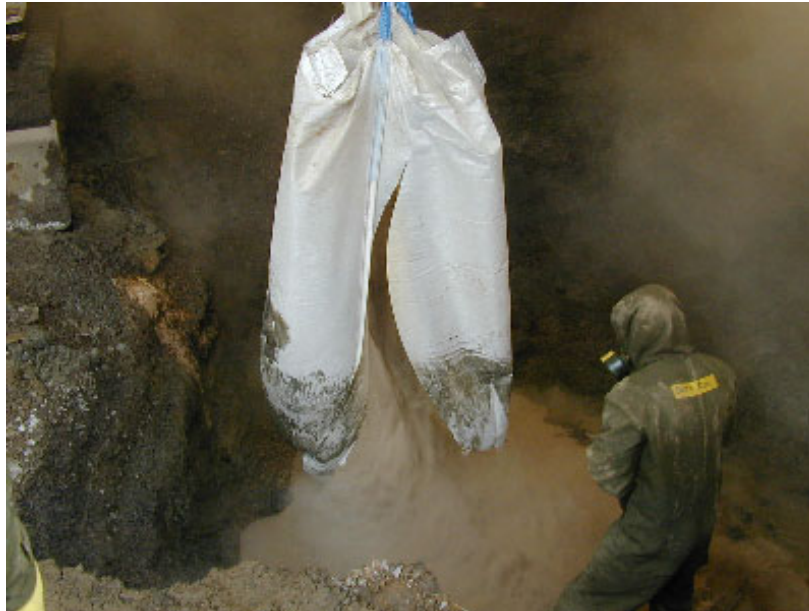
Fig 37. *Zeolite being distributed over the bedrock.*

As discussed, a major portion of the remediation plan saw the use of Zeolite as the primary method of absorbing contaminants from soil and standing water. (Fig 37) With this in mind, a layer of Zeolite was placed atop the bedrock thus preventing the migration of any hazardous product should it be present, (CWA or otherwise). This was done prior to the excavation being backfilled with blended Zeolite and soils.
